Dowel Bar Retrofit

Linda M. Pierce, PE
State Pavement Engineer
Washington State Department of Transportation

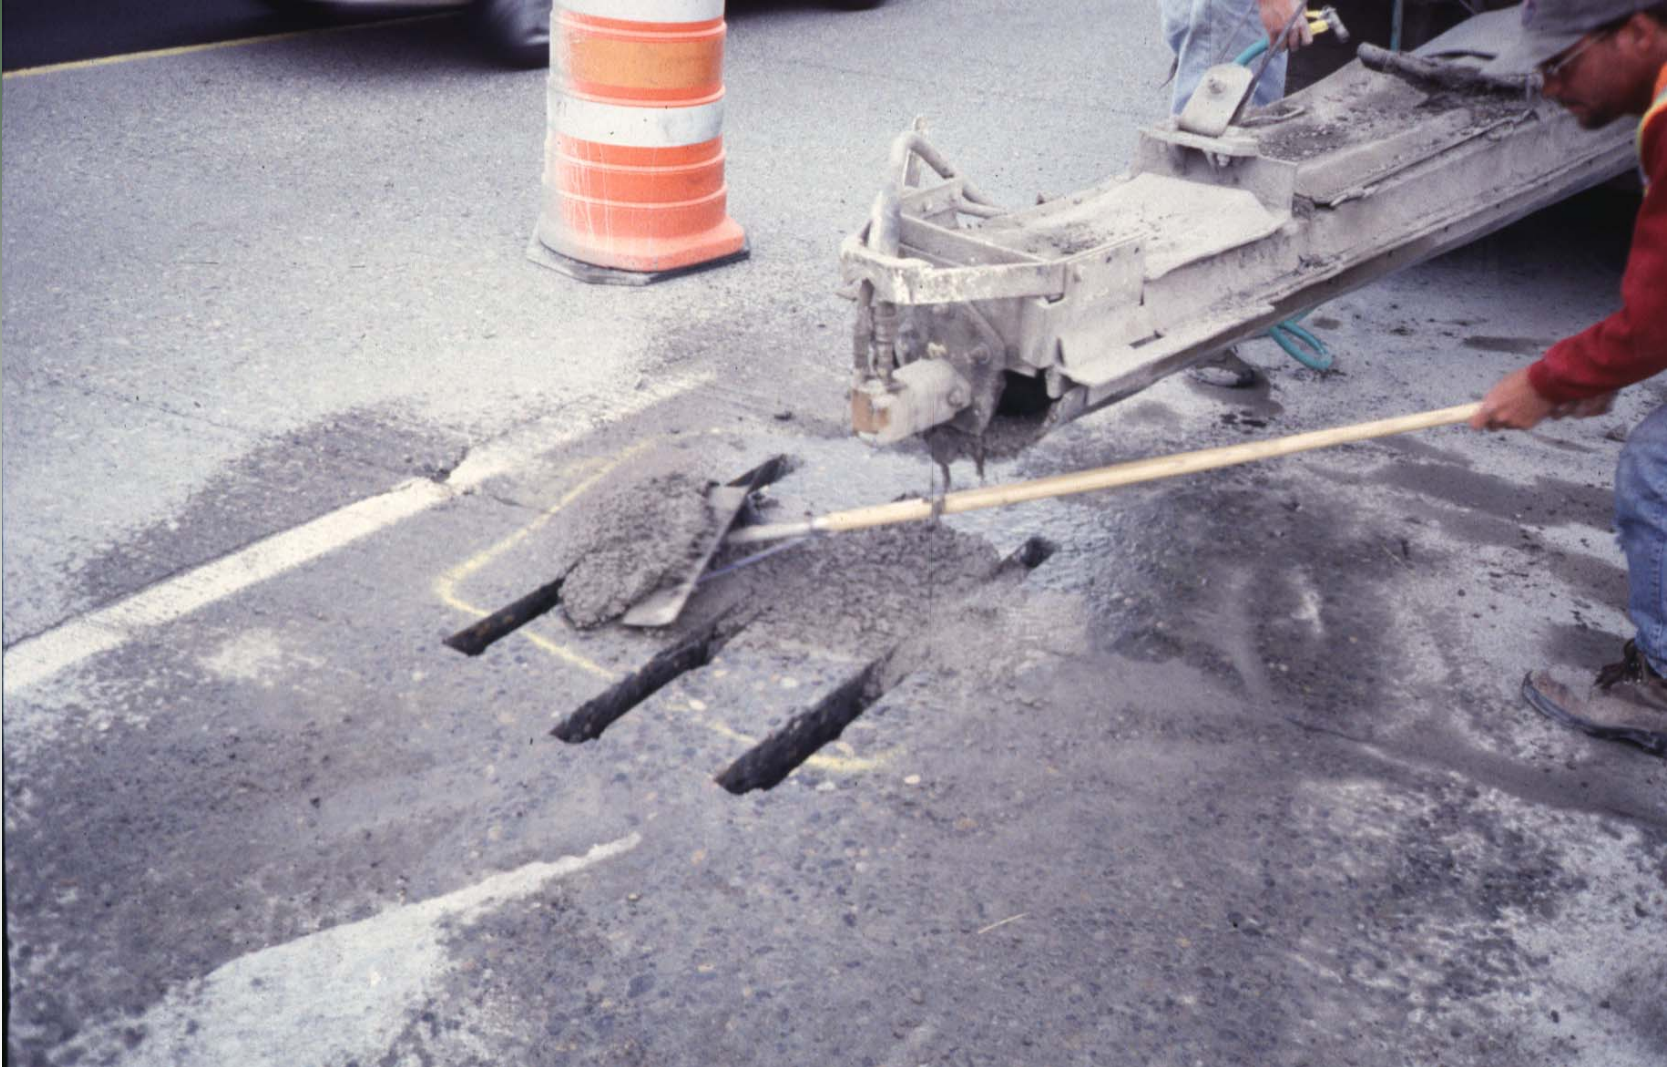
Placement of grout

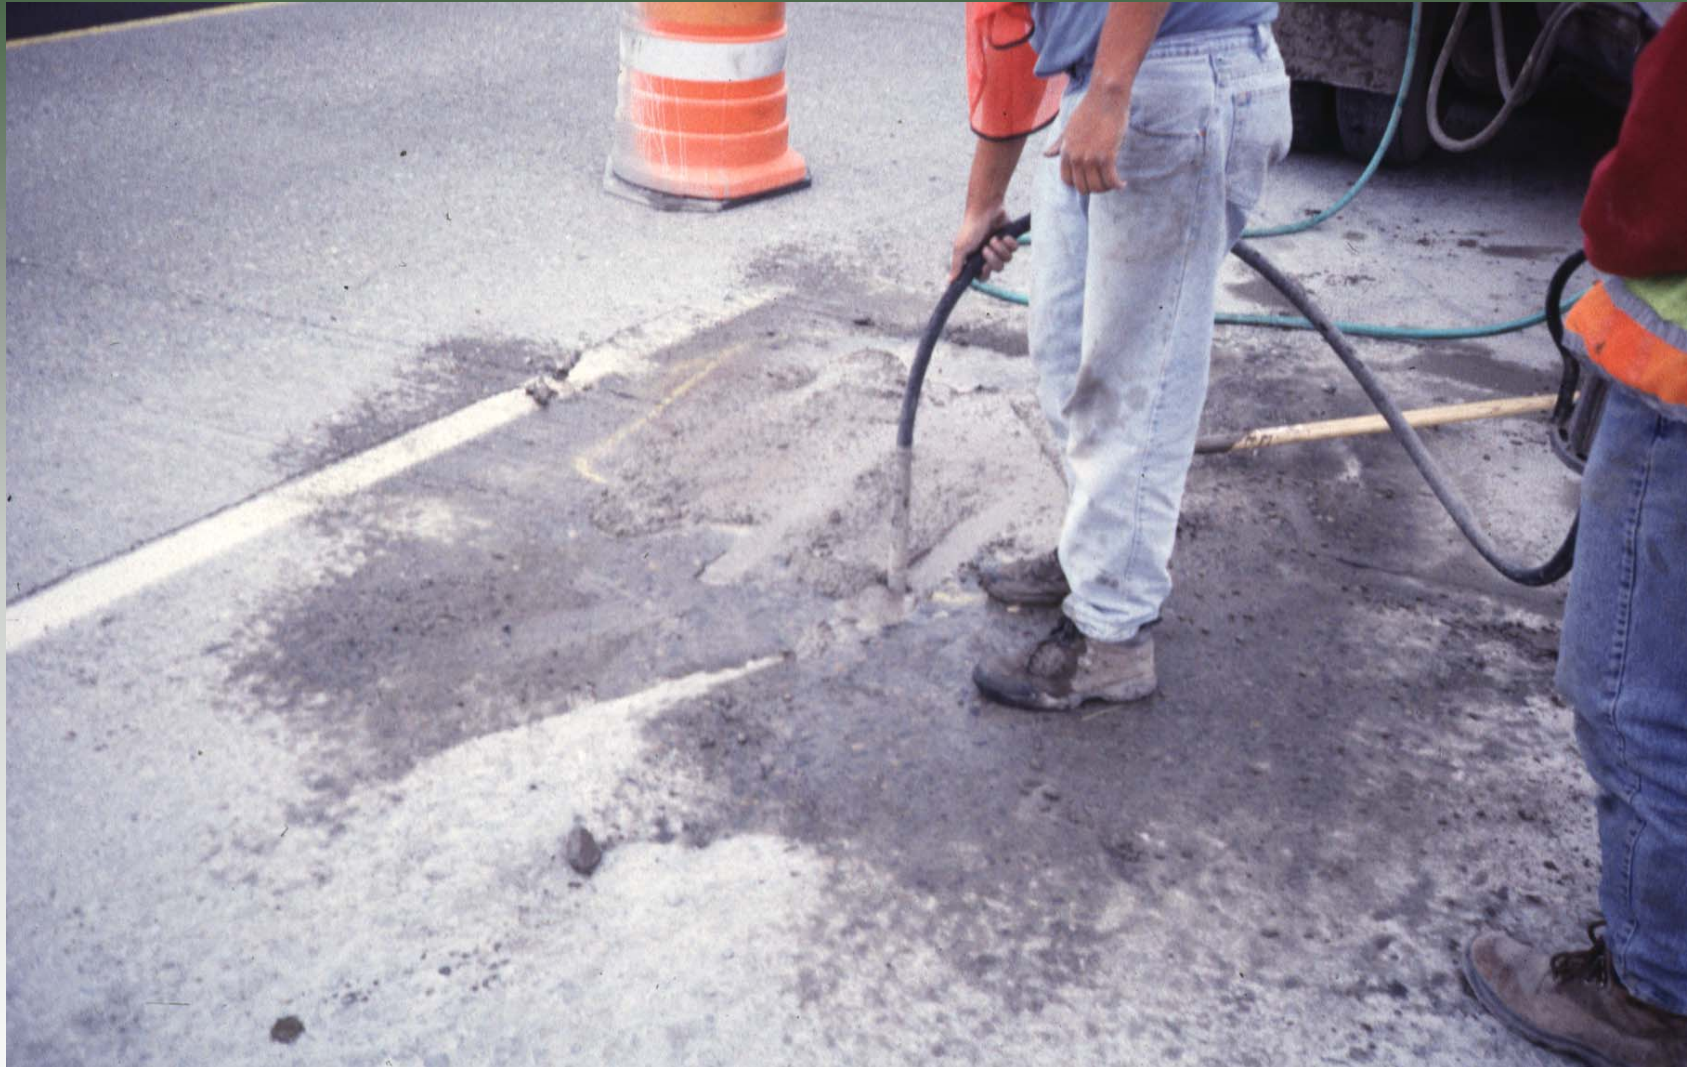
Consolidating grout

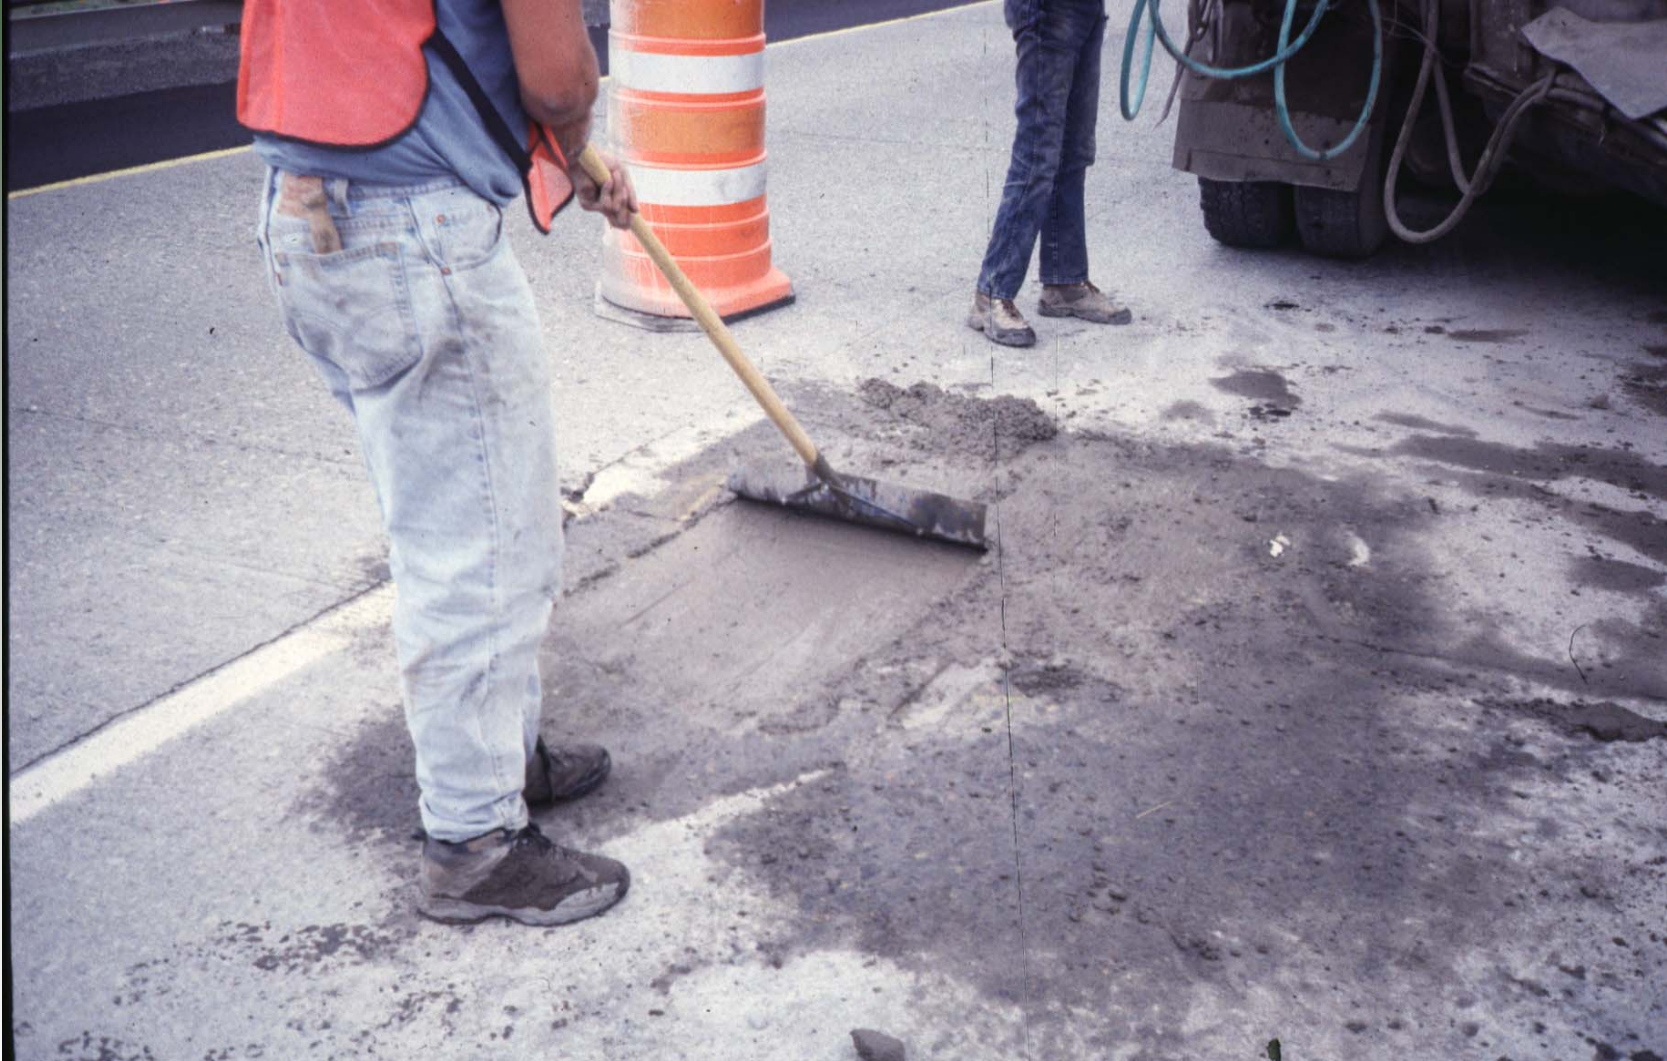
Striking of excess

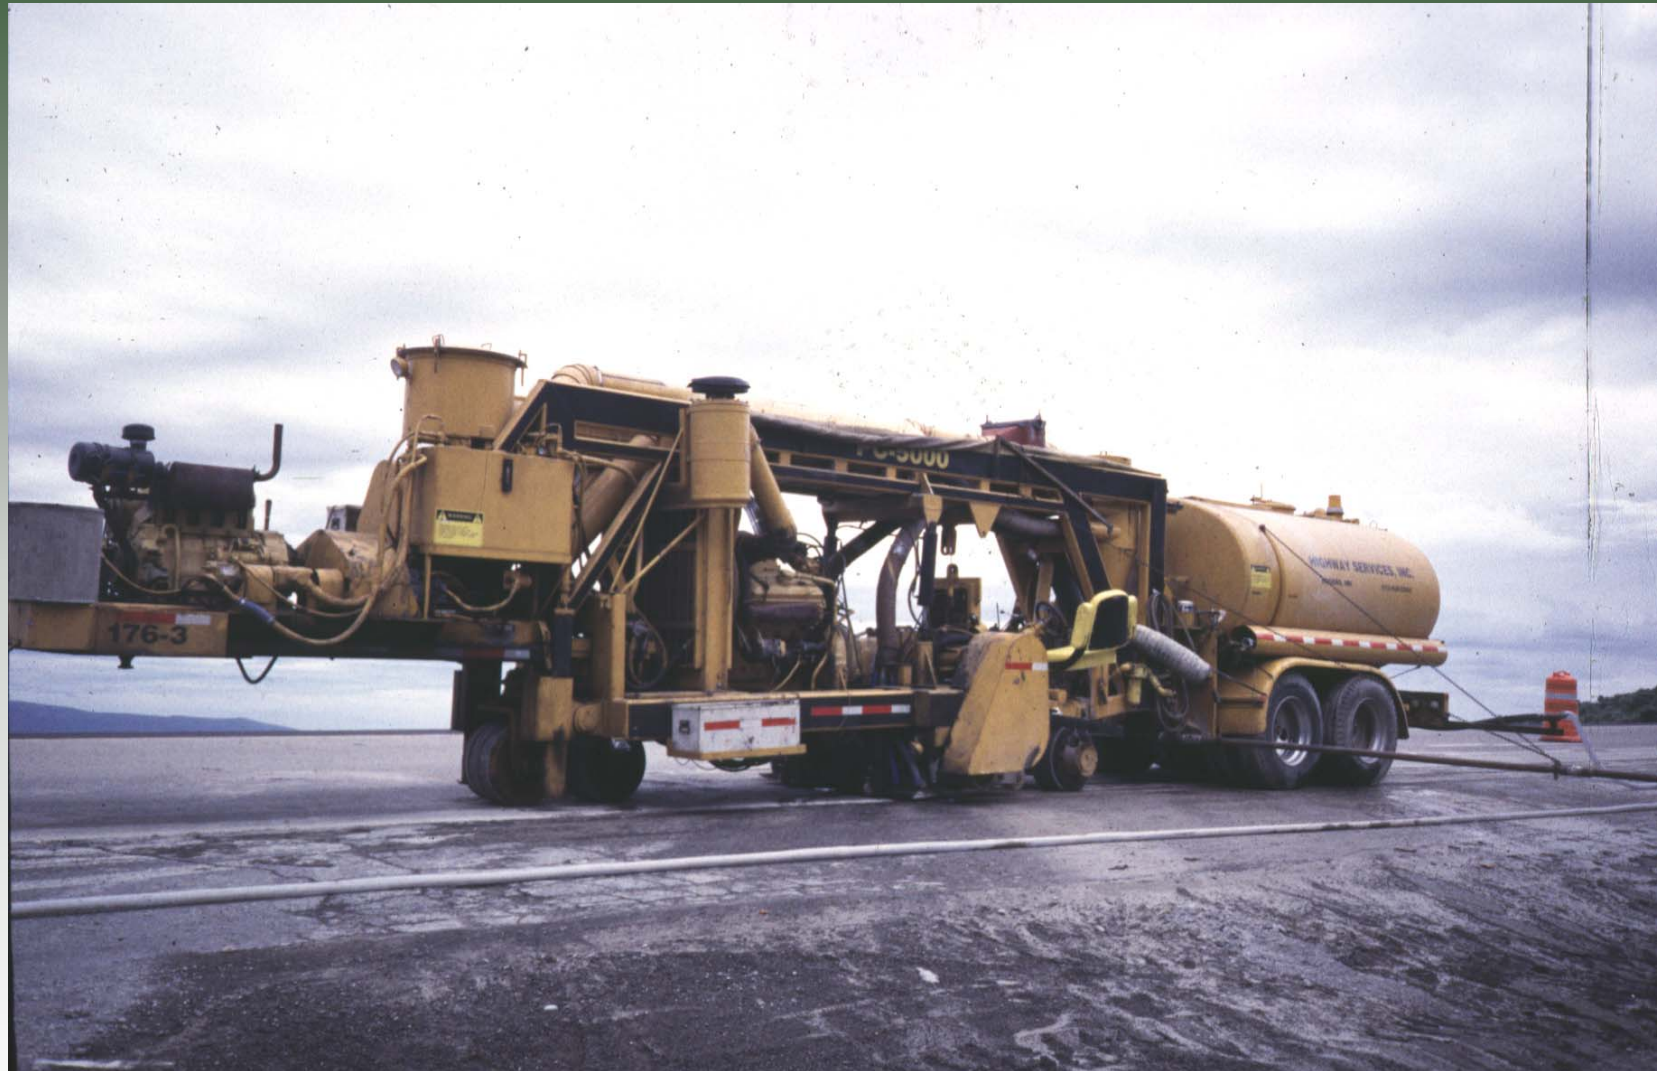
Diamond grinding

- ▶ **Restores pavement ride**
 - Removes faulting
 - Removes wear
- ▶ **Retexture roadway**

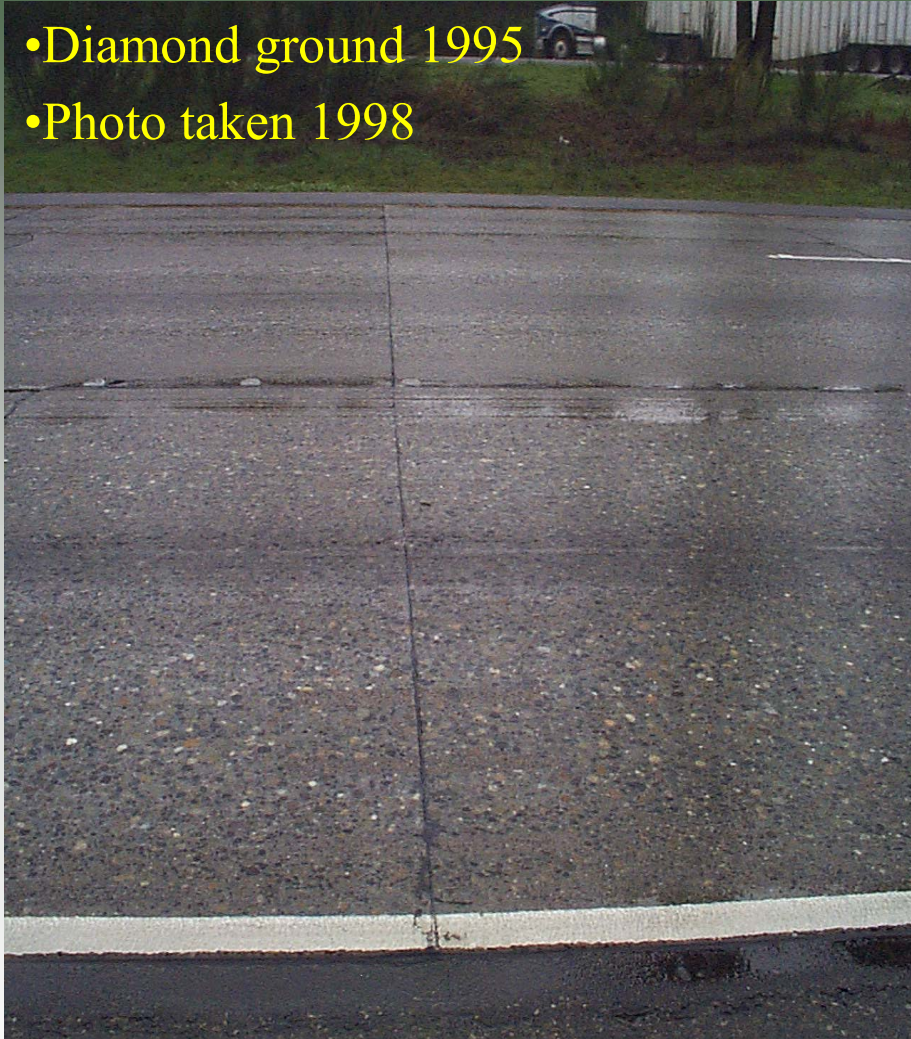
Diamond Ground Surface

- Diamond ground 1995
- Photo taken 1998

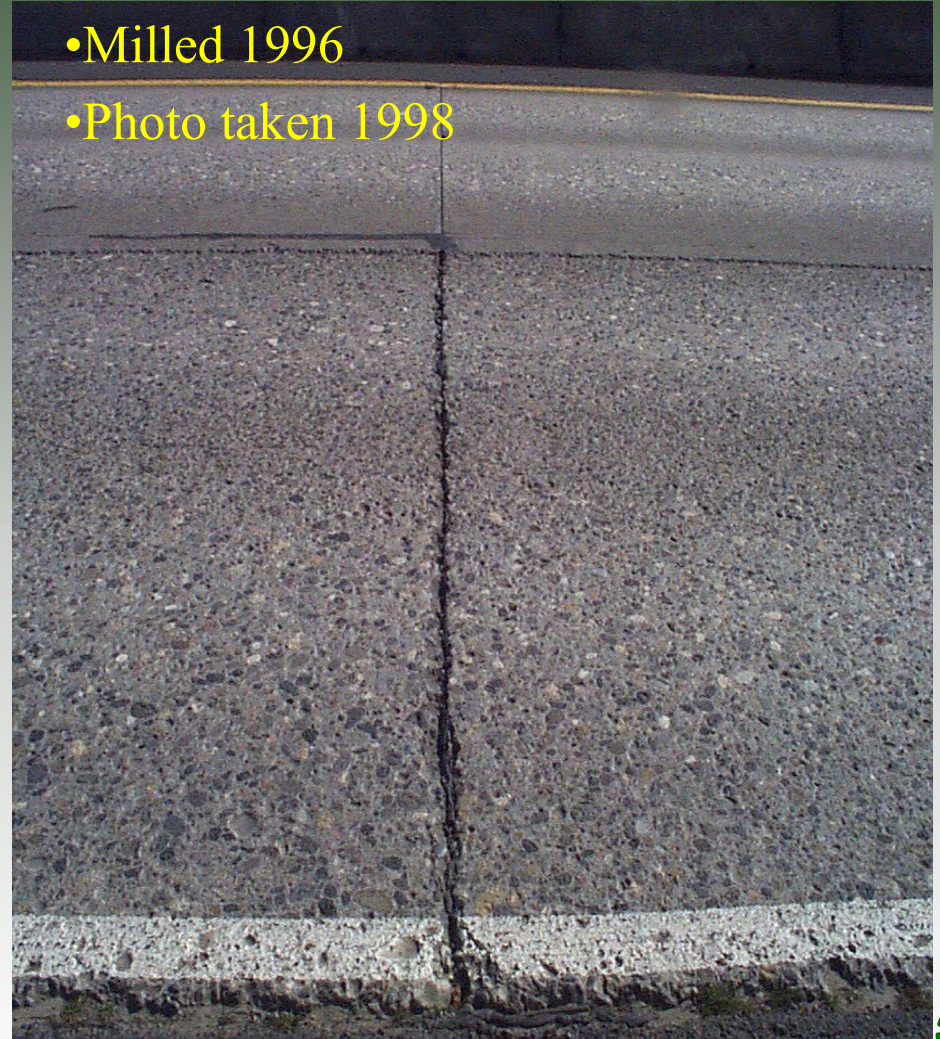
Milled Surface

- Milled 1996
- Photo taken 1998

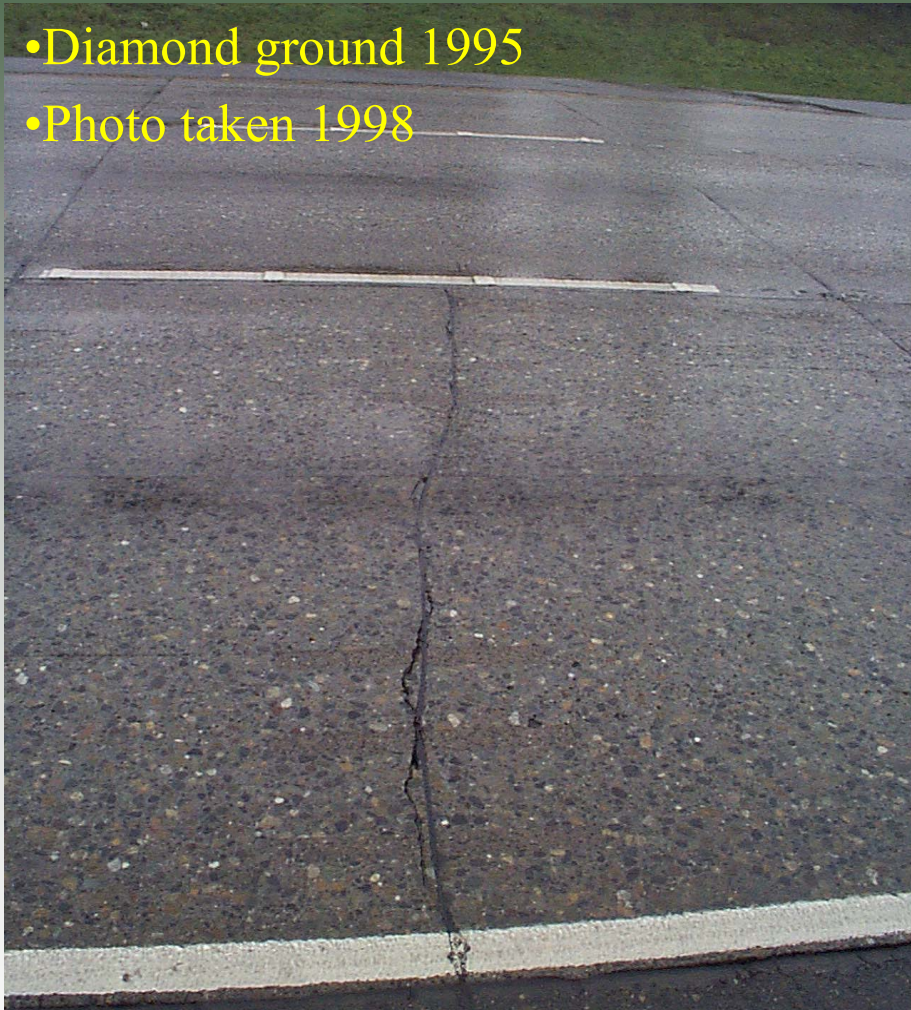
Diamond Ground Surface

- Diamond ground 1995
- Photo taken 1998

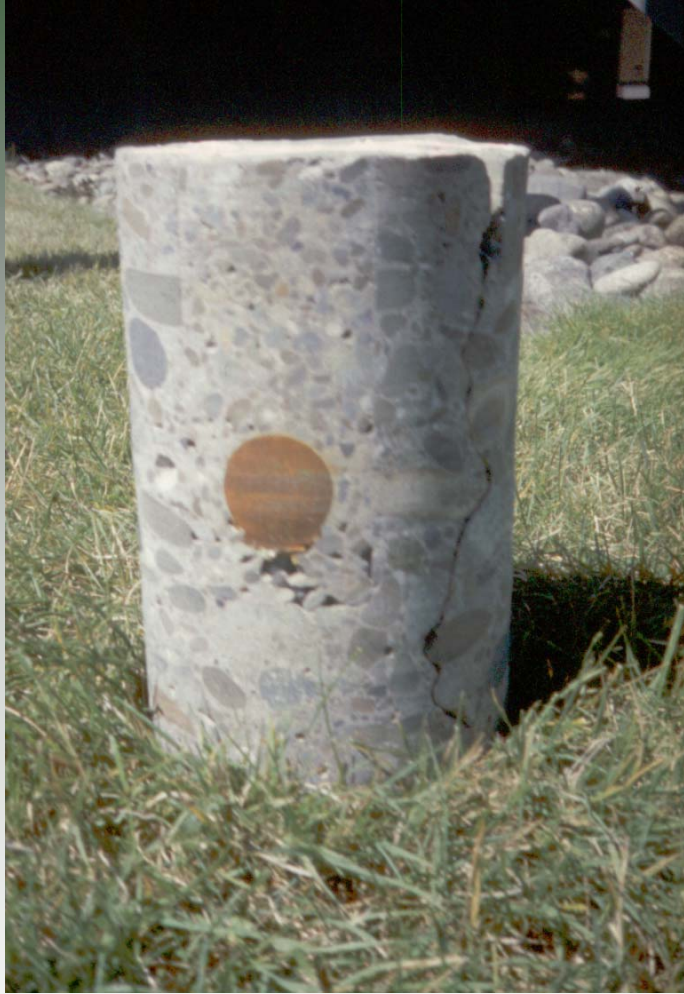
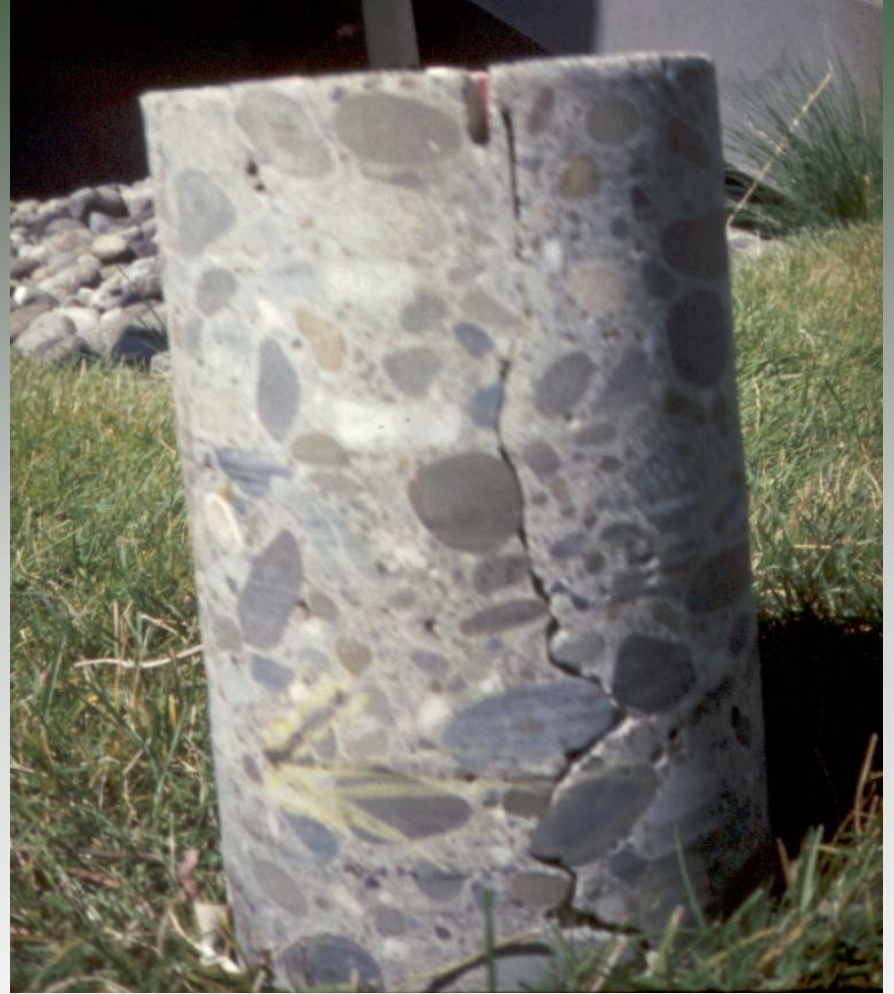
Pavement Cores

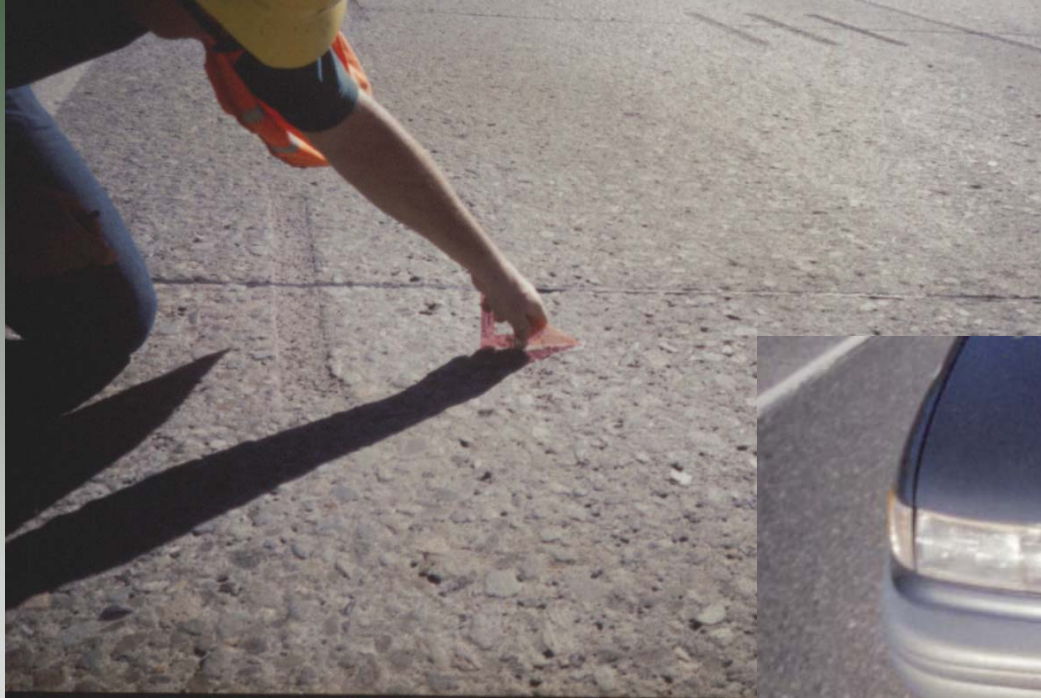
Studded Tire Wear

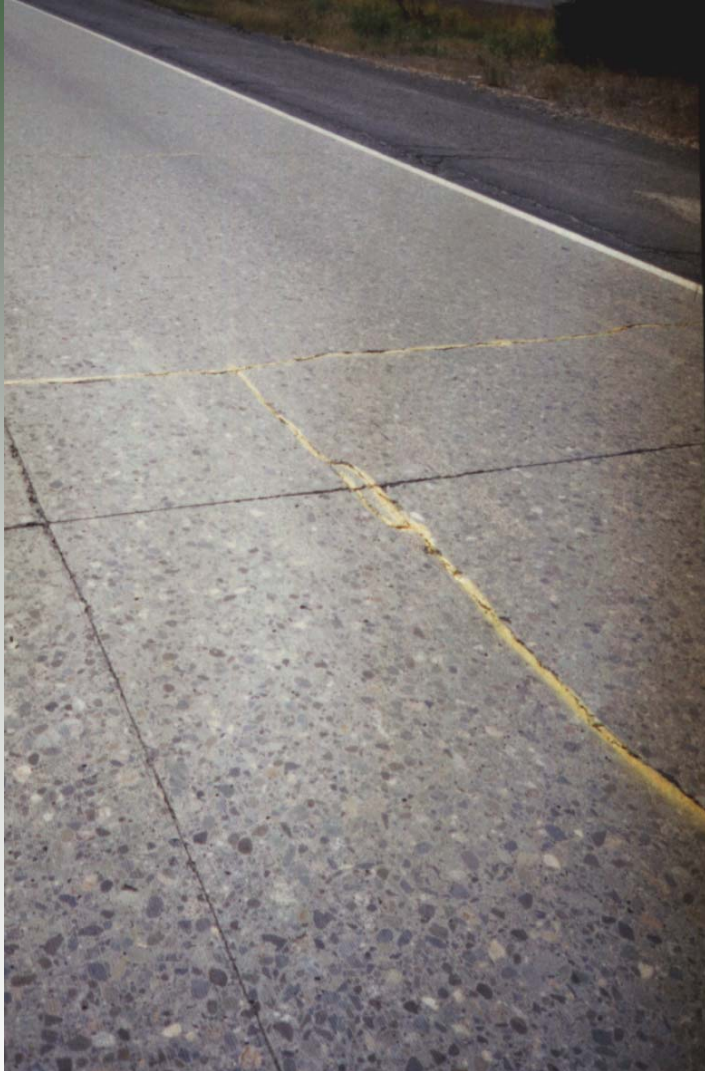
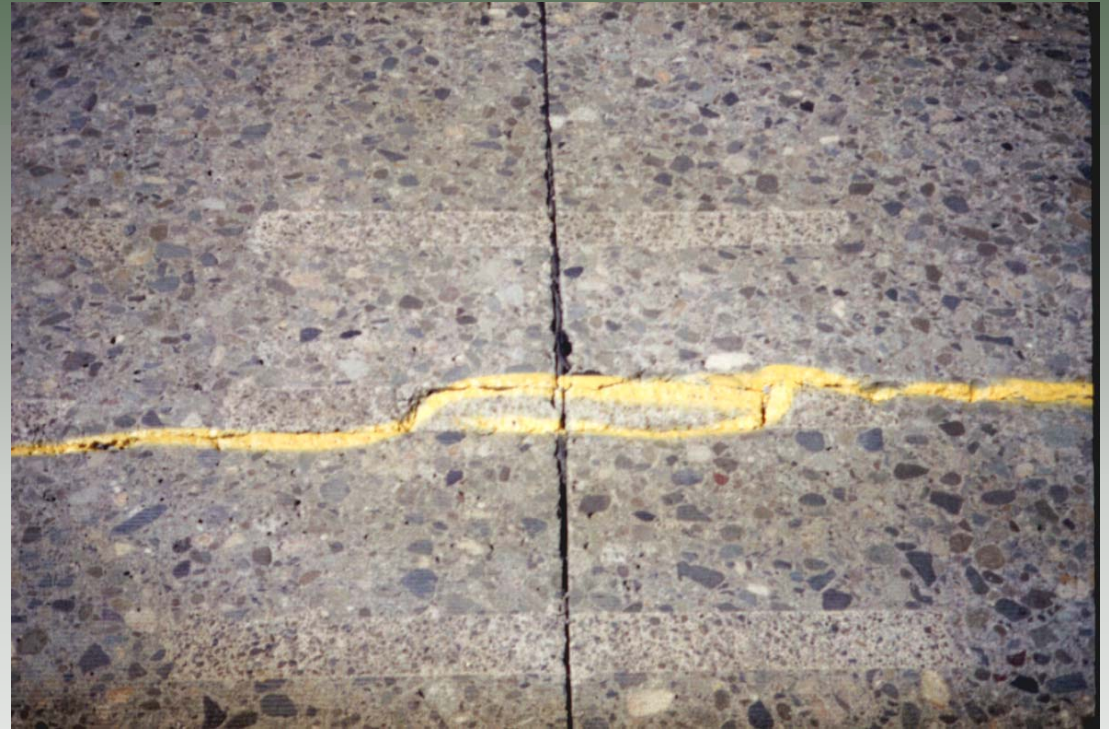
Longitudinal Cracking

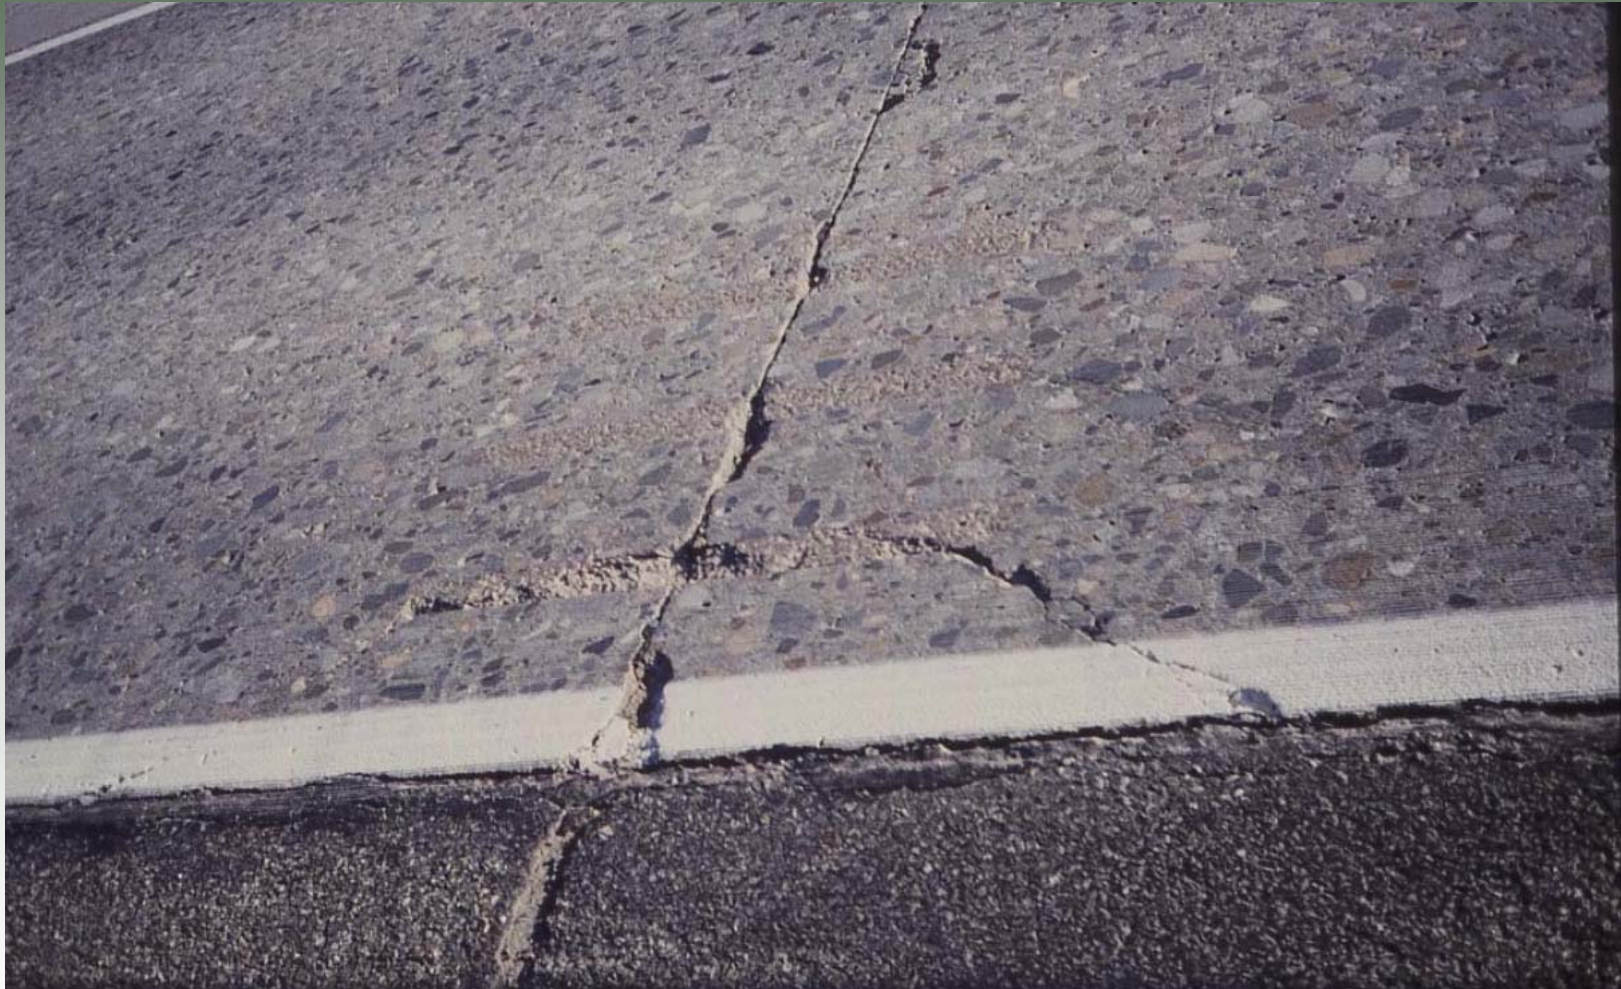
Construction Related Cracking
